Probable Hydrologic Consequences of Coal Mining in the Mohrland Permit Area

C.W. Mining Company, Huntington, Utah

February 9, 2007

Alan L. Mayo, PhD

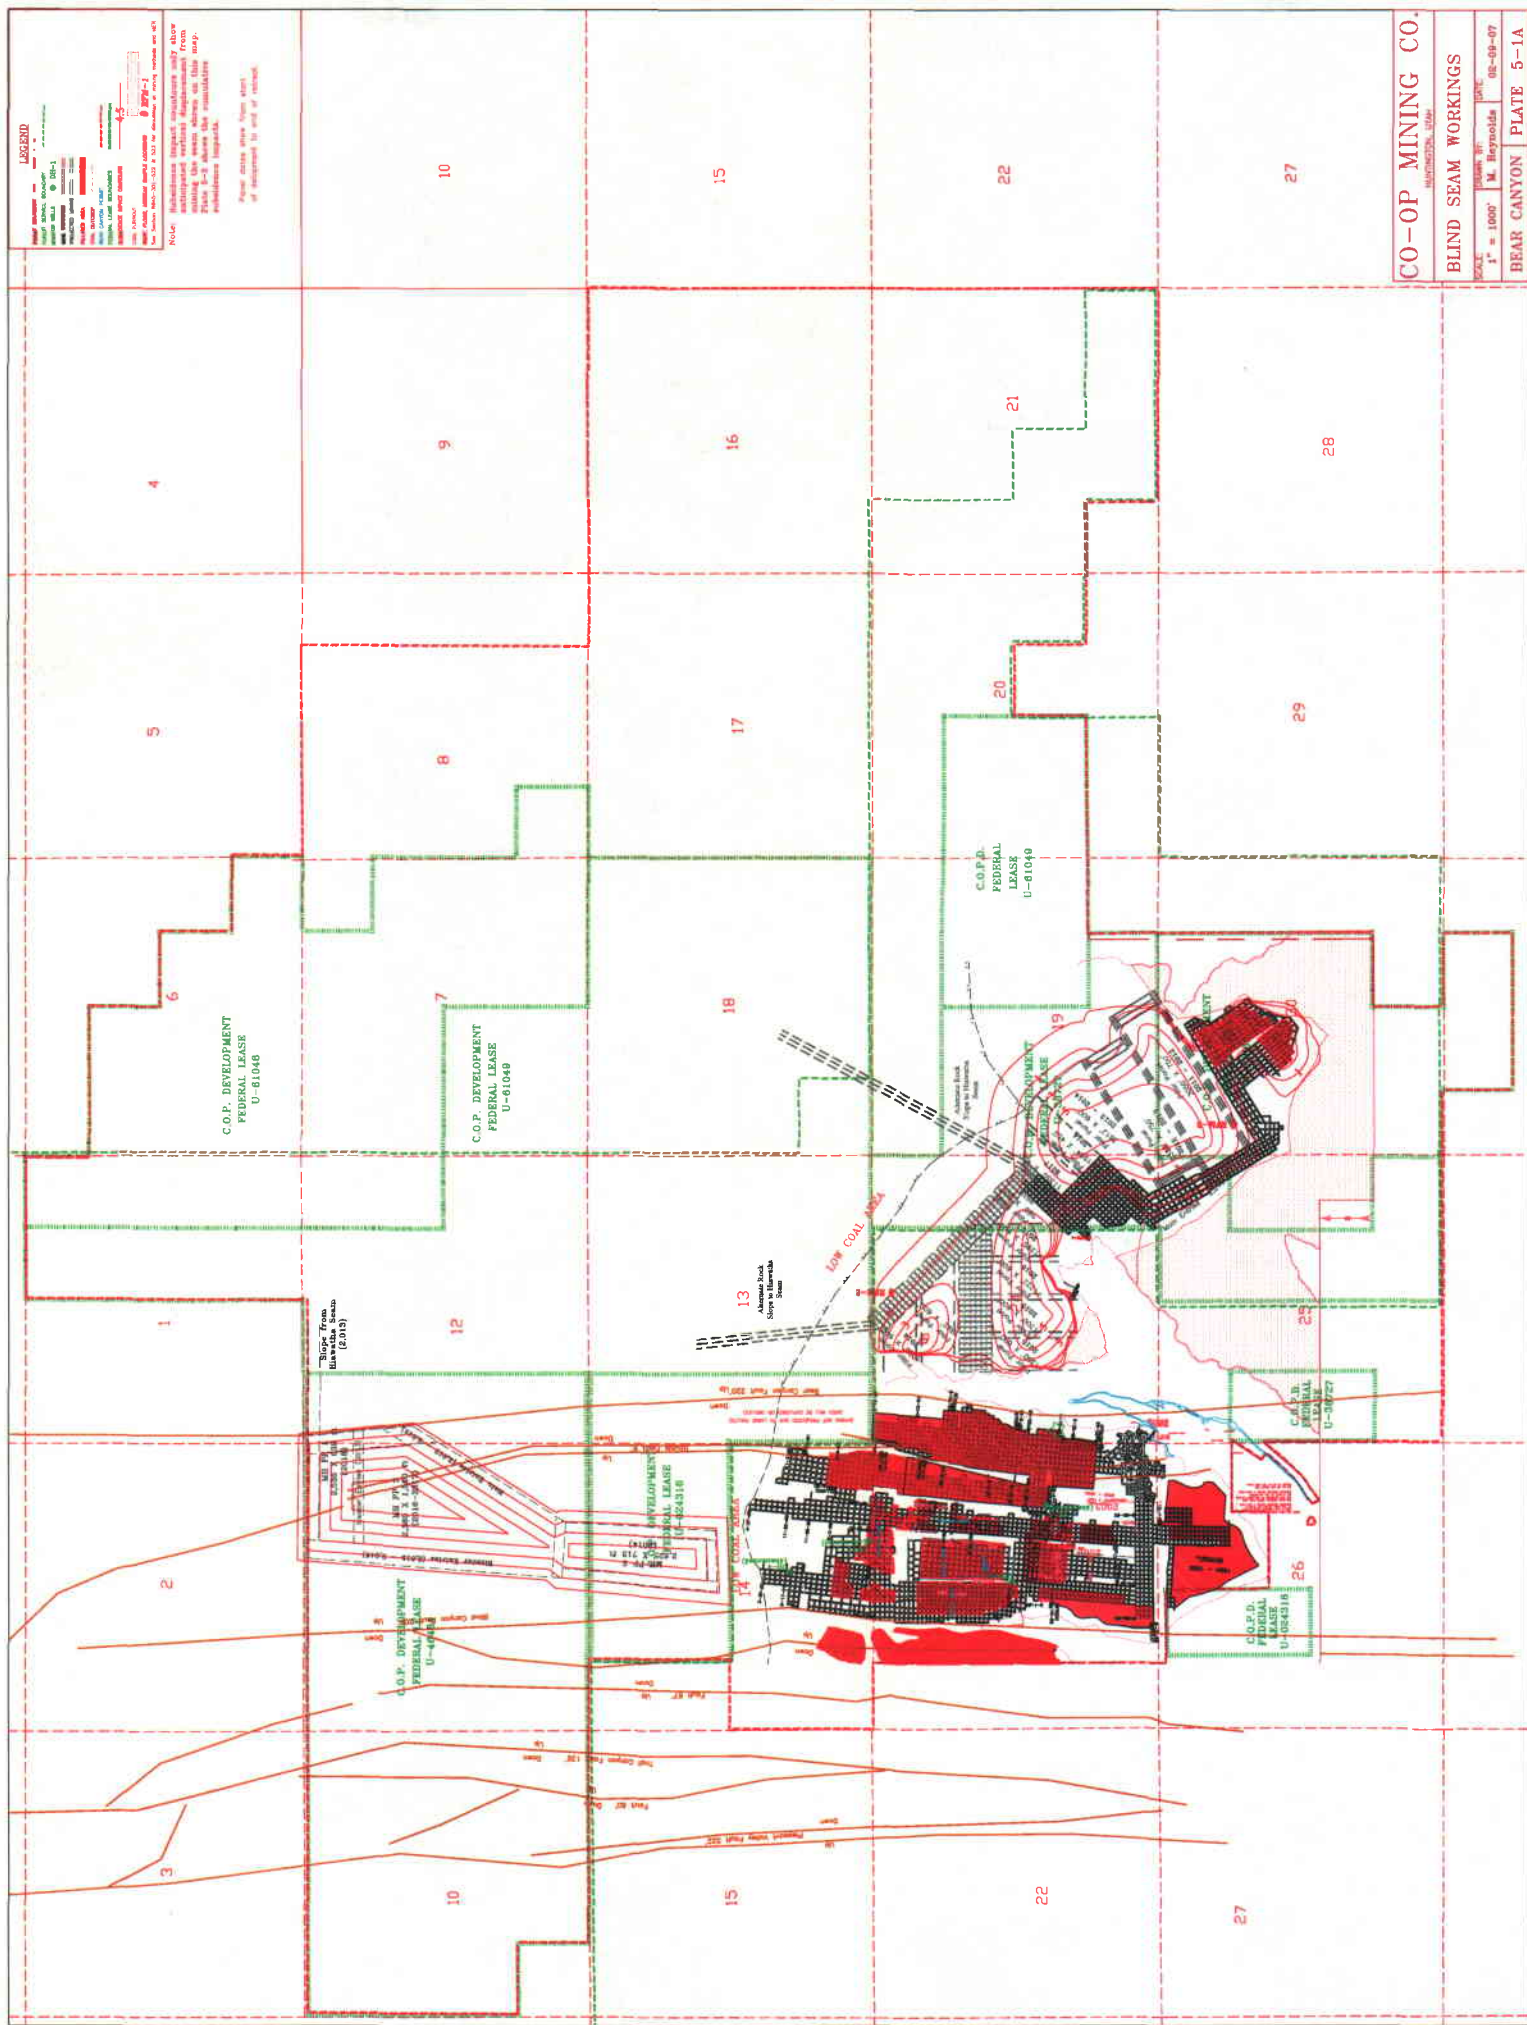
Permit Area

- D. ~~T16S, R7E SLBM Sec. 25 E1/2~~
 T16S, R8E SLBM ~~Sec. 30 W1/2, W1/2 NE1/4, NW1/4 SE1/4~~
 Sec. 31 NE1/4 NW1/4, NW1/4 NE1/4
- E. T6S, R8E SLBM Sec. 19 Lot 1, NE1/4 NW1/4, N1/2 NE1/4
 Sec. 20 N1/2 NW1/4, NE1/4, NE1/4 SE1/4
 2 W N N S S S 1 S W 1 W
 SE1/4

Note: Letter corresponds with ownership shown in Table 2-1-3
